## AES December 2014Site Visit Photo-Documentation

José A. Rivera Senior Environmental Engineer

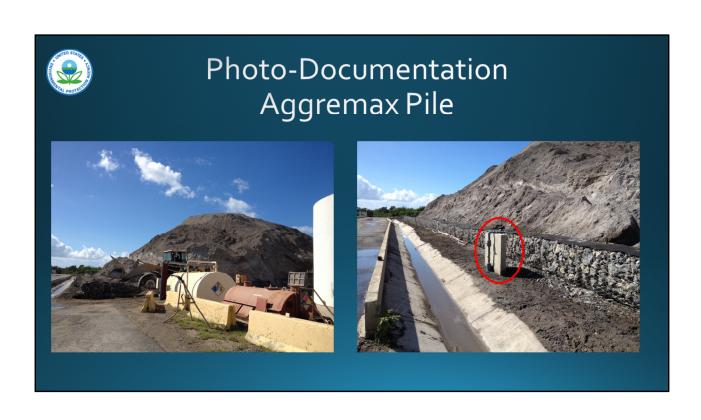
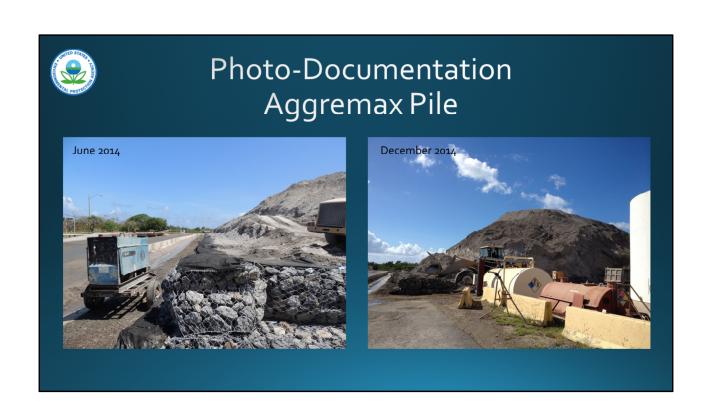
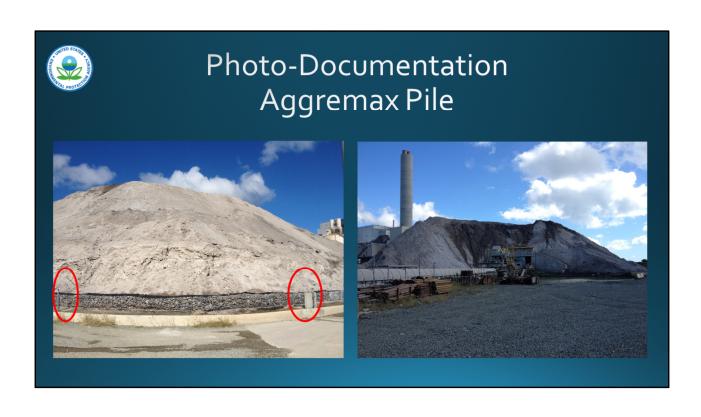
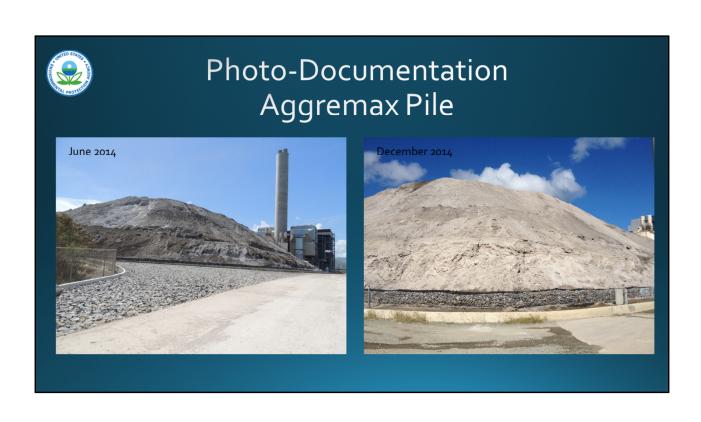
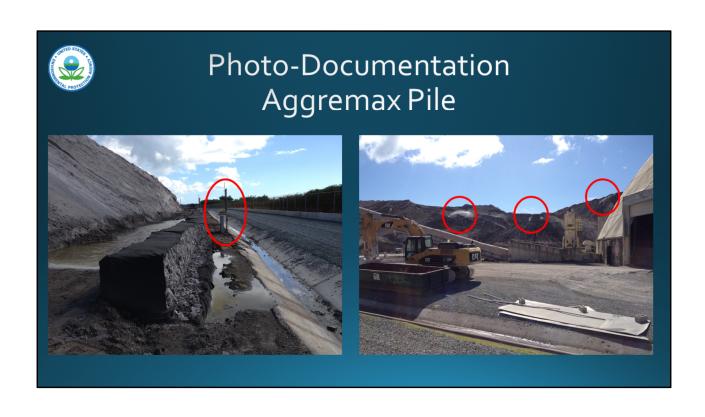
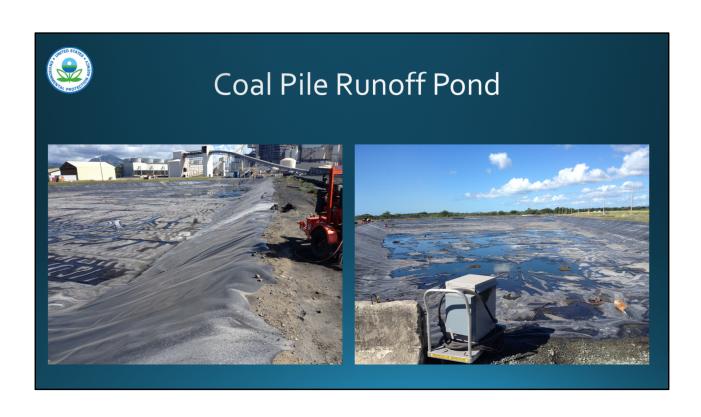
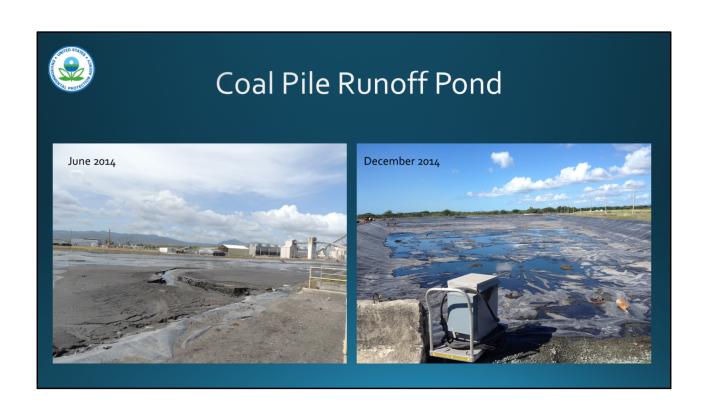
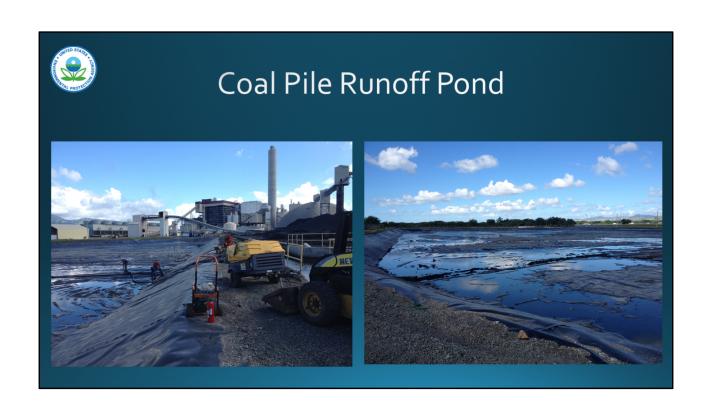
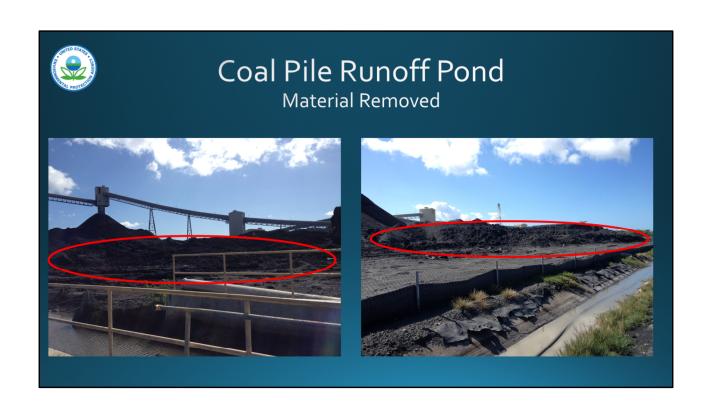
- Aggremax pile is significant lower than when was last seen during the June 2014 visit
  - 150,000 tons removed since June 2014
  - 260,000 tons removed so far during 2014
  - Installation a new pipeline system and 8 water hose connection stations for Aggremax pile water irrigation
  - Three (3) sprinklers were observed in operation at the top of the Aggremax pile (near the north and northwest)per.
- Coal Pile Runoff Pond
  - Empty and clean of sediments/coal
  - Final stages of liner repair
  - Pending small repairs scheduled to be completed by end of December 2014

- Walkthrough took place to check on the Aggremax Pile, Coal Pile, Limestone Dome, and Coal Pile Pond Areas
- Crushed stone re-application observed on the internal road along the south boundary
- Water mounted-tank truck sprinkling water on internal roads
- Mechanical Sweeper
